QUARTERLY GRAIN REPORTStation Fishkum Refuge.Period May 1 to August 31, 1944

HAYING AND GRAZING

Refuge Benton Lake Year 1944

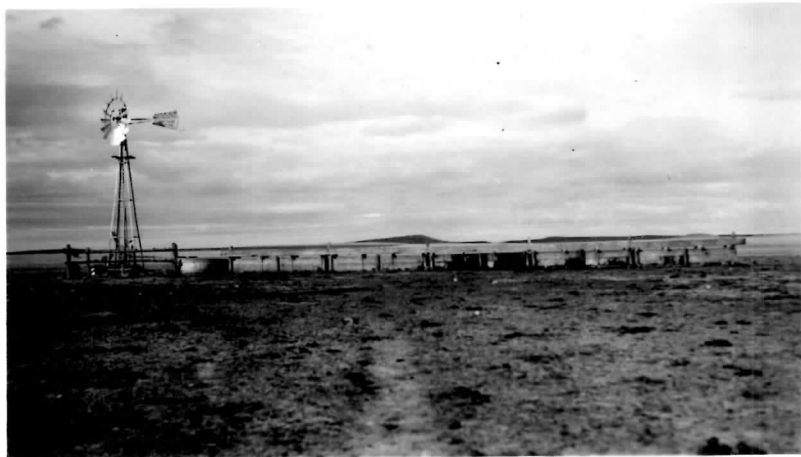
R-10 E-1, 10/5/44, Benton Lake: Overall view of stock watering unit. 5 new wood tanks 2x4x14', and an A. B. Wisconsin air cooled engine and pump jack are new equipment owned and installed by the stock grazing permittees.

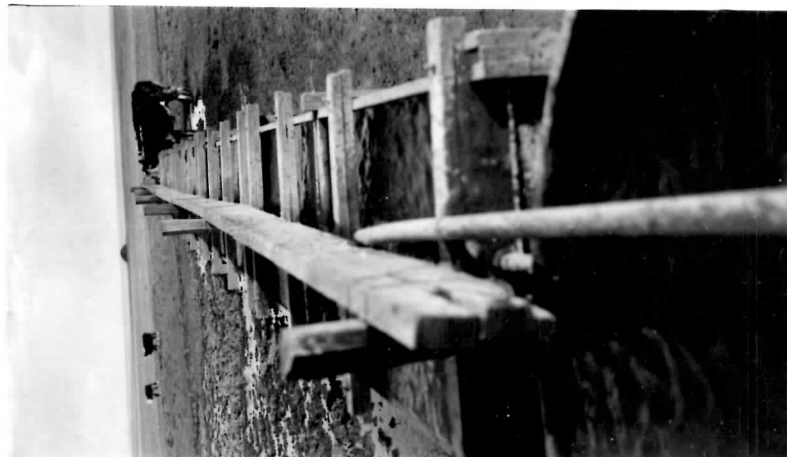
R-10 E-2, 10/5/44, Benton Lake: Top view of new watering tanks. Note the sturdy construction and the impossibility of cattle being pushed or bunted into the tanks. Also note how dry the ground is on the upper side of the tanks.

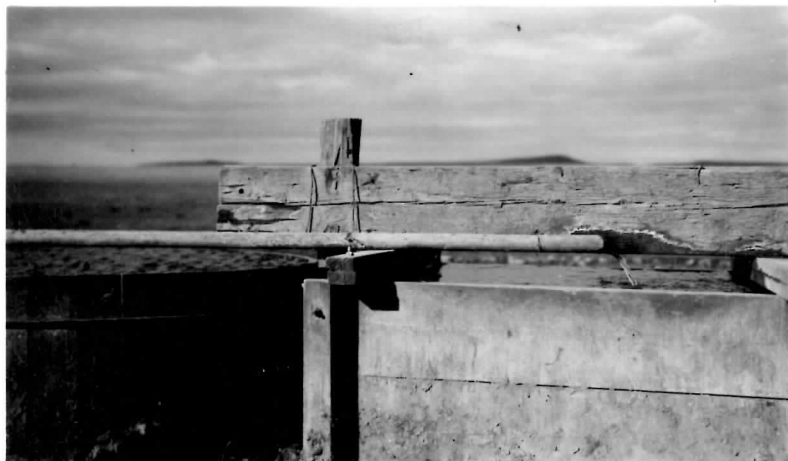
R-10 E-3, 10/5/44, Benton Lake: A 2" pipe carries the water from the pump. It was found that a more uniform level could be maintained in the tanks if the water from the pump was run into the second tank instead of the first.

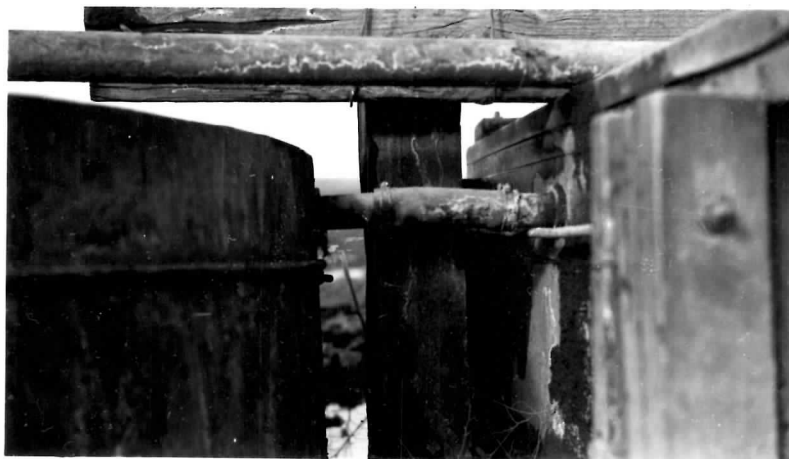
R-10 E-4, 10/5/44, Benton Lake: 1½" galvanized pipes with rubber hose was used in connections between tanks. This rubber hose will be a guarantee against breaking out the ends of the tanks as it will allow for give or settlement of tanks.

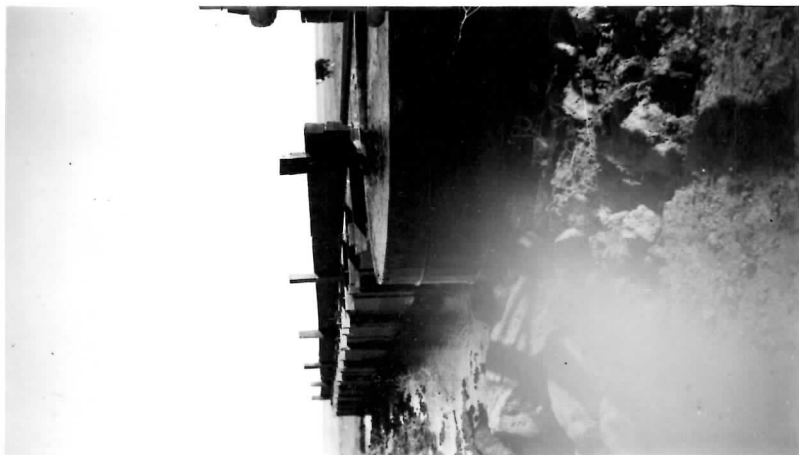
R-10 E-5, 10/5/44, Benton Lake: The $1\frac{1}{2}$ " connections between tanks and $1\frac{1}{2}$ " overflow in the last tank are not sufficient to take care of all the water when pump is operating at maximum capacity. Note overflow in first tank.

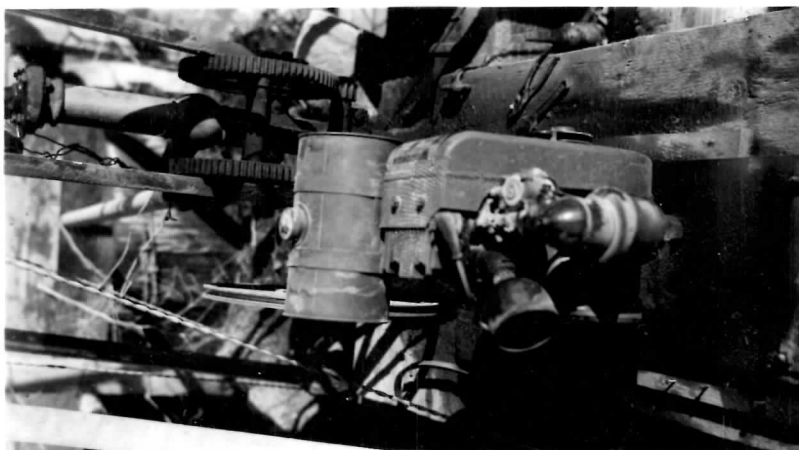
R-10 E-6, 10/5/44, Benton Lake: A two to three horse power engine with pump jack is used to operate pump during periods of insufficient wind.

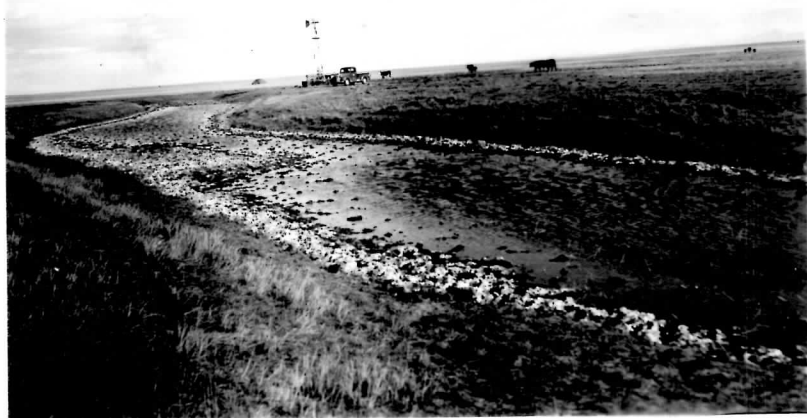
R-10 E-7, 10/5/44, Benton Lake: This reservoir which is about 6" deep, averages about 20' wide and is about $\frac{1}{4}$ mile long and was created after the installation of the new equipment. Besides making additional storage for stockwatering purposes it is a good small area for waterfowl.

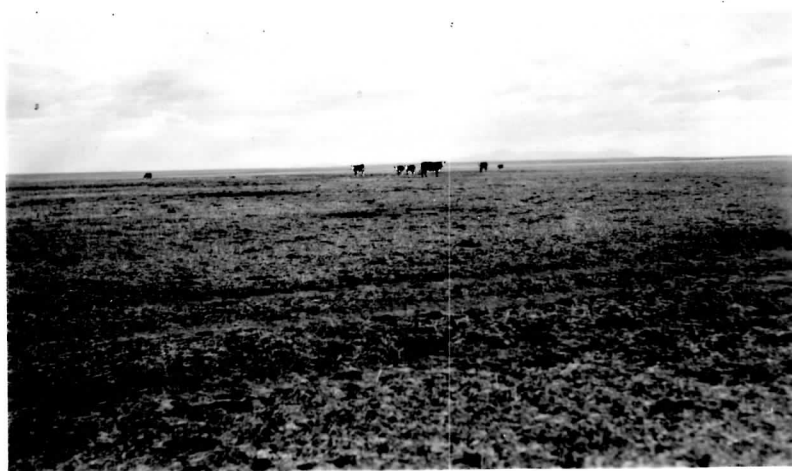
R-11 E-1, 10/5/44, Benton Lake: The area within a radius of about $\frac{1}{4}$ mile around the watering unit is grazed and trampled very heavily. Several watering places are needed in an area as large as Benton Lake Refuge.

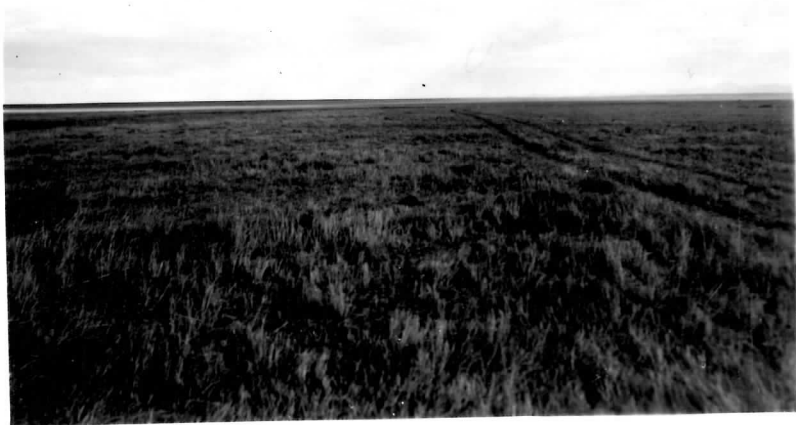
R-11 E-2, 10/5/44, Benton Lake: Outside the $\frac{1}{4}$ mile radius of the watering unit, grass conditions are somewhat better but even here for about another $\frac{1}{4}$ to $\frac{1}{2}$ mile there is much indication of over grazing.

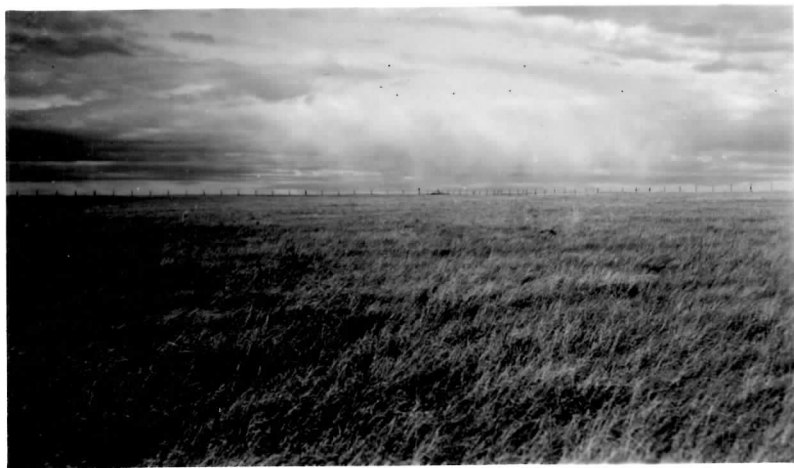
R-11 E-3, 10/5/44, Benton Lake: Note the difference in density of forage along outer edge of refuge as compared with conditions close in around watering unit.

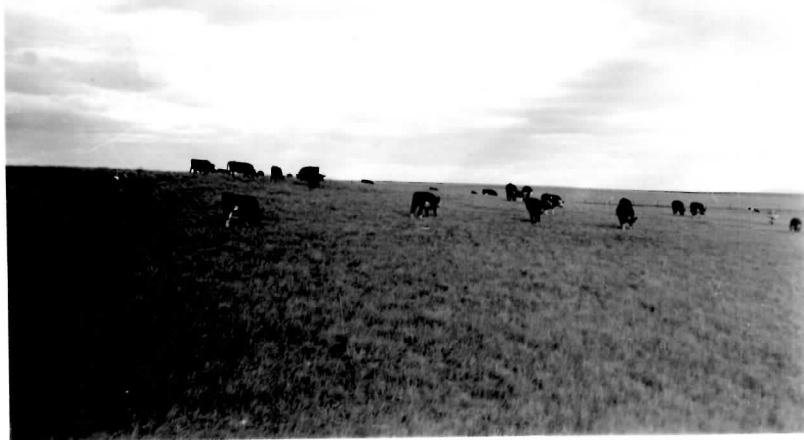
R-11 E-4, 10/5/44, Benton Lake: During the latter part of the grazing period when weather was not so hot, cattle grazed farther away from the watering unit. The above cattle are grazing along the eastern edge of the refuge. Note how slick and fat these animals are.
